City of Ralston, Nebraska

Redevelopment Area #2

Blight & Substandard Determination Study

August, 2023.

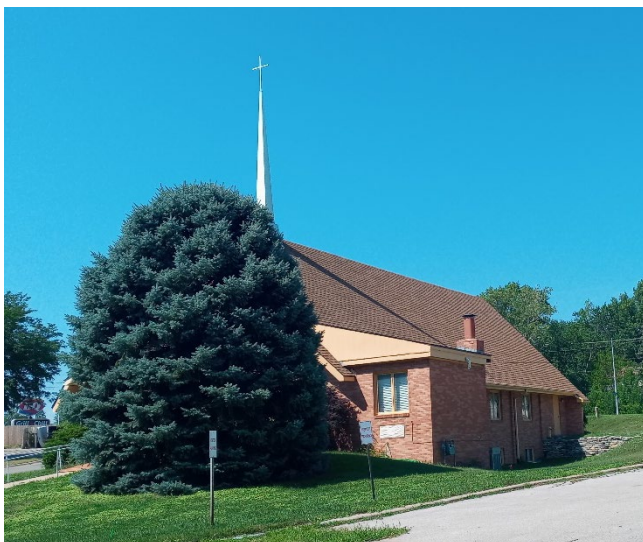
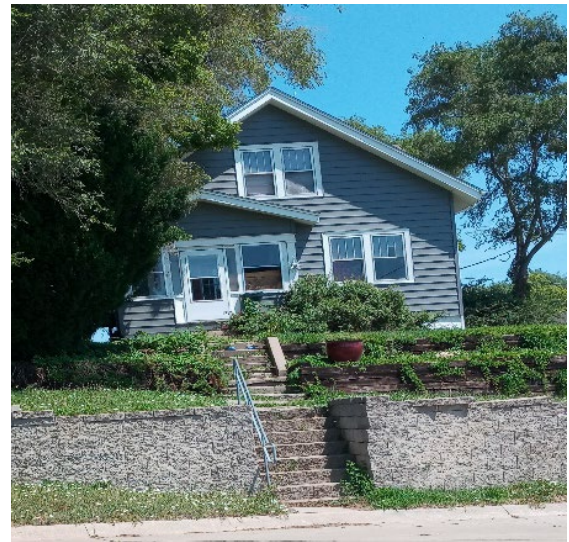
**ILLUSTRATION 9
AGE OF STRUCTURES MAP – INSET A
REDEVELOPMENT AREA #2
RALSTON, NEBRASKA**

The age and obsolescence of structures is a strong presence throughout Redevelopment Area #2.

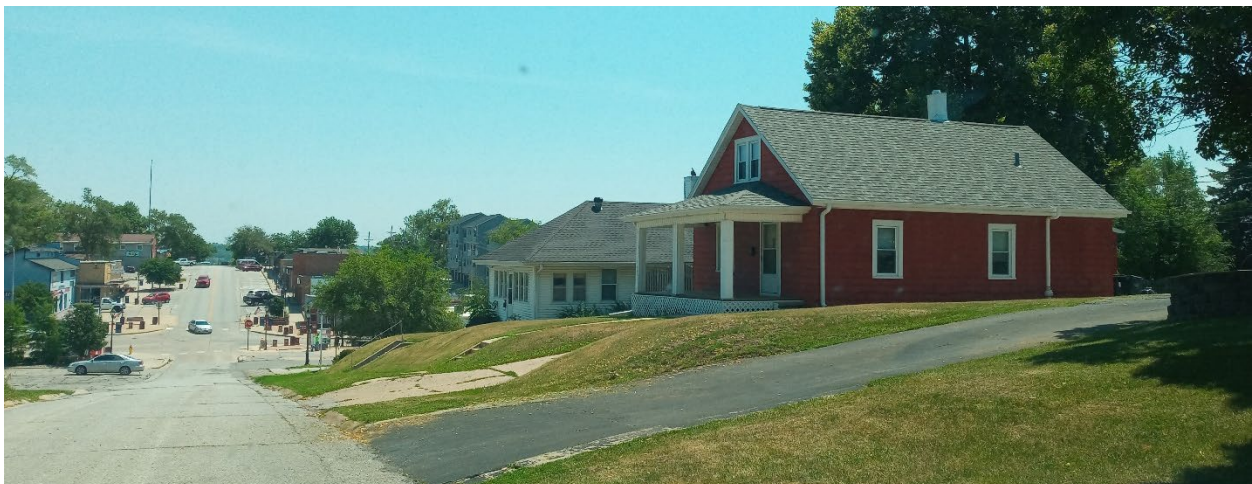
**ILLUSTRATION 12
STREET CONDITION MAP - INSET A
REDEVELOPMENT AREA #2
RALSTON, NEBRASKA**

The Factor of defective or inadequate street layout in the City of Ralston Redevelopment Area is a strong presence.

Existence of Defective or Inadequate Street Layout is a **strong presence** throughout the **Redevelopment Area**. The primary streets providing access throughout the **Area** include Harrison Street, South 84th Street, and Park Drive. The **Redevelopment Area** contains a variety of street types including north-south, east-west grid configurations in the Downtown and curvilinear streets in the southwest corner of the **Redevelopment Area**. Of the 90 parcels, 27, or 30 percent were located along a street in “**fair**” condition. Additionally, 40 parcels, or 44.4 percent lacked access to the public sidewalk or contained a sidewalk in “**fair**” to “**poor**” condition.
